REPORT
ON THE
RENEWAL
OF
NIAGARA SUSPENSION BRIDGE.

BY
LEFFERT L. BUCK,
CIVIL ENGINEER.

1880.

ON THE REINFORCEMENT OF THE ANCHORAGE AND RENEWAL OF THE SUSPENDED SUPERSTRUCTURE OF THE NIAGARA RAILROAD SUSPENSION BRIDGE.

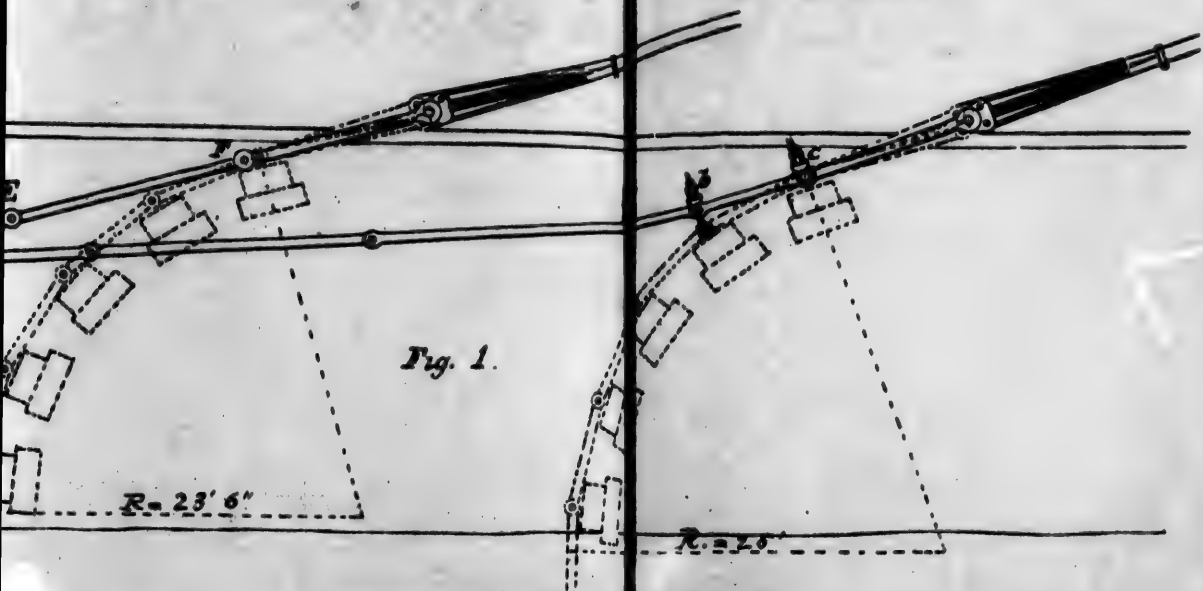
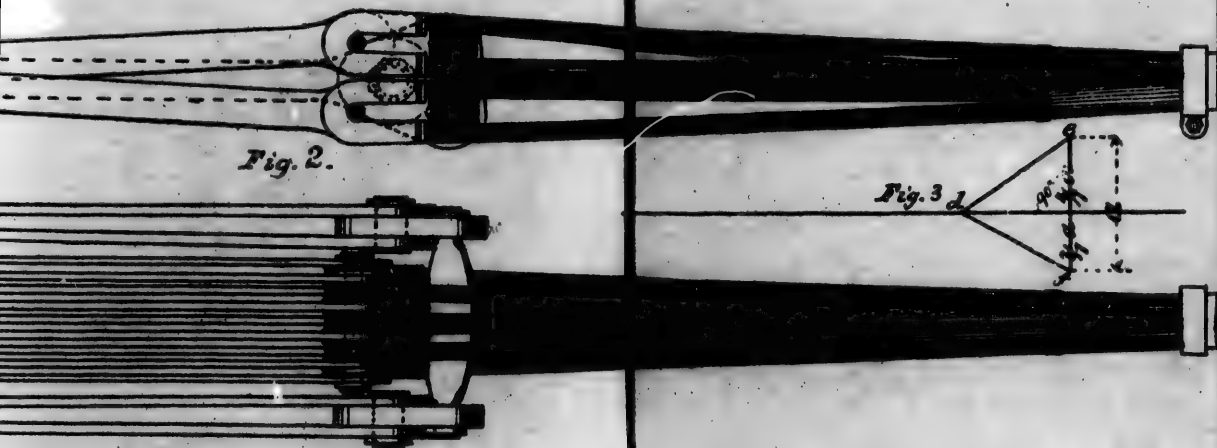
PLATE I.

A rectangular pit or shaft, 3 ft. x 7 ft. in plan, was sunk vertically into the rock, to a depth of 25 feet, with the bottom enlarged to form a chamber 7 ft. square. An anchor plate, 6 ft. 6 in. square and having seven rectangular openings through it to receive the lower links of the anchor chain, is set in the chamber, the links put in position and secured by a $3\frac{1}{2}$ inch diameter pin passed through their heads and underneath the plate. From the plate the chain passes vertically upward to the surface of the rock. From this point the joints of the chain are at points of a vertical curve of 25 ft. radius. The joint at the upper end of the curve forming the point of tangency with the line of the cable. Beyond this joint is another length of chain composed of nine links, each bar of which is 10 feet long and 7 in. x $1\frac{1}{2}$ in. section. Four of these links alternate with the shoes of three of the strands of the cable and are secured to them by a $3\frac{1}{2}$ in. diameter pin passing through links and shoes. The remaining five links are in like manner connected with the remaining four shoes of the cable strands, as shown in elevations (Figs. 1 and 2).

The anchor plates are secured in the chambers by means of neatly fitted stone blocks set in cement mortar, the whole pit being solidly filled with cement masonry and the interstices around the bars grouted. Above the rock and up to the end of the chain the whole is enclosed in a solid wall of masonry, heavy blocks of which form supports of the joints of the curved portion of the chain. Formerly the strands were also covered with masonry and the whole grouted, the intention being to preserve them from corrosion.

Thus it was found that the only wires affected were the outer wires of the outside strands. Near the cylindrical portion of the cables, the outer wires were slightly rusted clear around the cable, but as we approached the shoes, the etching appeared to work toward the lower strands, till, when the shoes were reached, the principal corrosion was of the outer wires underneath the bottom shoes.

The evident cause of this corrosion was the elongation and contraction of the strands under the passing loads, which had loosened the cement from the outside strands, allowing moisture to work in and finally reach the lowest point. The portion of cement among the strands would go and come in a body with them.

From the condition of the cement around the curved portion of the chain it appears that the masonry covering them in the wall was put on before the weight of the bridge came upon them. As this weight was added the curved portion of the chain had settled forward toward the river and downward. This settlement was greatest near the top of the wall. From this point downward it decreased till about the third joint down where it was very slight. That such settlement had occurred was shown by there being cavities behind the chains and ends of the pins, both of which were rusty, while in front of the chains and pin ends the cement was close, and when chipped off left the iron bright as when new.

The connection with the strands was made as in the first plan, excepting that instead of the last links attaching directly to the cross bars, a triangular link is interposed, as shown by the dotted line in Fig. 2. The arrangement of the holes in this link is shown in Fig. 3. The object of the link is to cause a proper distribution of the strains. There being three strands above and four below, three-sevenths of the strain should go to the upper, and four-sevenths to the lower strands. Hence the resultant of the strain on the entire chain was made to coincide with the center line of the cable at this point. *e* and *f*, the centers of the upper and lower cross bars respectively, are in a plane at right angles to the center line of the cable, and the line joining *e* and *f* is intersected by the center line at a point, distant from *e*, four-sevenths of the whole distance, *a*. *d*, the point of attachment of the chain to the triangular link, is on the center line of the cable.

The rust was all scraped off and the old chains painted, after which they were re-grouted and covered by the masonry, so that no water can reach them again.

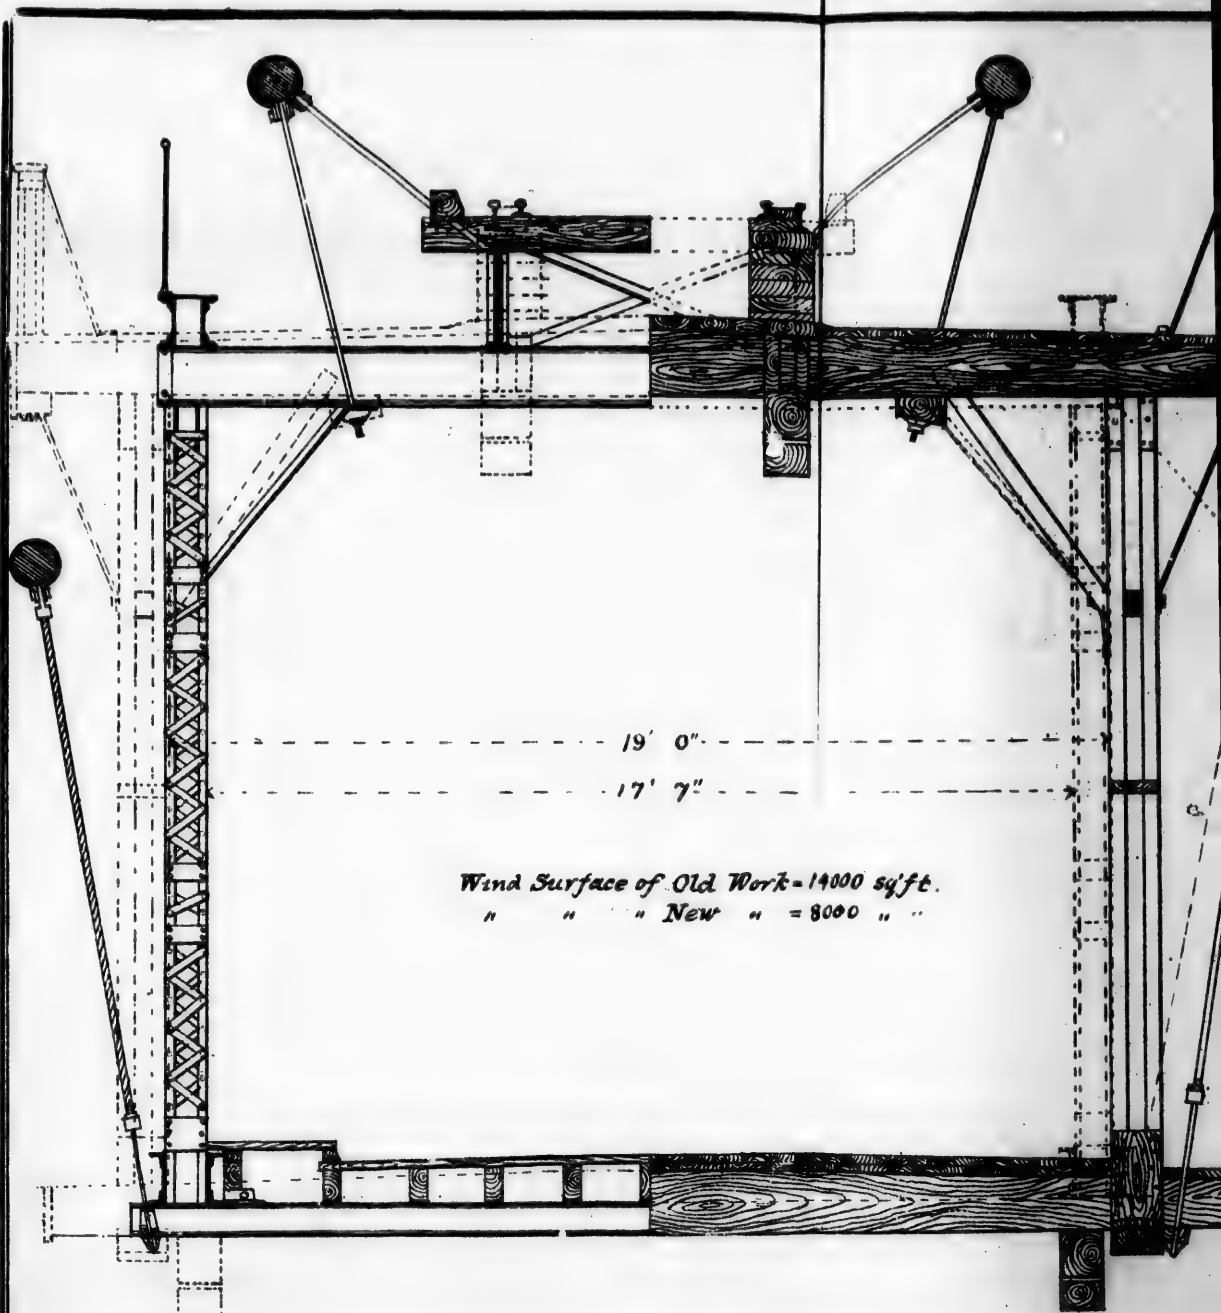
Transverse View showing relative positions of old and new work.

As first built the superstructure was as follows (see right hand half of transverse view and side elevation of old truss, plate IV.)

After the bridge had been in use for some time, it was found that the lower floor did not assist the chords until the latter had been overstrained, after which the constant working of the joints at the intersection of posts with beams and chords, had produced rapid decay of these parts. As they became weakened and the stress came upon the floor planking, the screws holding them to the beams were loosened, allowing moisture to get in and causing the upper edges of the beams to rot.

THE CONDITION OF THE OLD TRUSSES.—About the year 1873, the upper floor had been renewed. The lower had, in addition to the auxiliary chords and slip beams (already mentioned), been repaired from time to time, new pieces being inserted, here and there, as the old ones had become decayed or broken.

As the strain from the trusses had to be transmitted to the auxiliary chords by the transverse stiffness of the floor beams, the frequent wrenching, to which these latter had been subjected, had opened their fibre, and, from the action of water and frost, had caused them to decay with excessive rapidity.

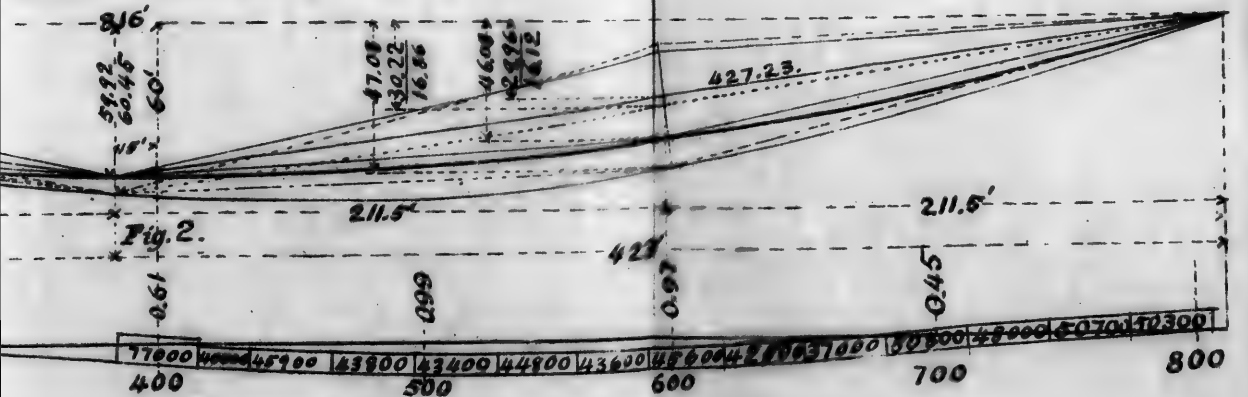
Fig. 2.

By applying the parallelogram of forces to the two segments of the cable (Fig. 2, Plate V), it is found that with the load in the position shown, covering a little over half the span, the intensity of the dead load of the unloaded segment balances not only the intensity of the dead load of the loaded segment, but .12 ton of the intensity of the live load beside. The total intensity of the live load $= \frac{357}{465} = .77$ ton. Consequently (w) in the formulæ $= .77 - .12 = .65$ ton. Substituting this in (2) we get—
